Preservation, Development and Use of the Nevada State Prison

78th Session – Nevada State Legislature – 2015

Nevada State Prison Steering Committee

September 2014

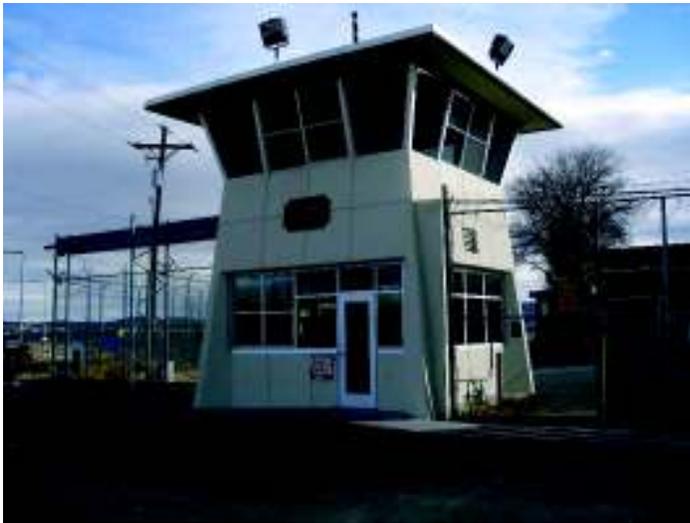
- The Main Gate / Tower 1 is located on the west side of the prison and next to a vehicle gate.
- This building is in generally fair shape.
- The building is a painted precast concrete structure that has two levels.
- It has approximately 450 square feet of space and was constructed in 1963.
- The lower level served as the visitor's check in and entry point into the prison.
- The upper level is the guard tower.

- The interior wall, floor and ceiling finishes are in poor condition.
- The interior finishes are faded and damaged to a point where the concrete walls and floors are showing wear and deterioration.

- The building's sanitary wastewater system is showing signs of deterioration.
- The drains operate slowly.
- Deposits within the pipes will cause them to be restricted, which will slow the flow of water.

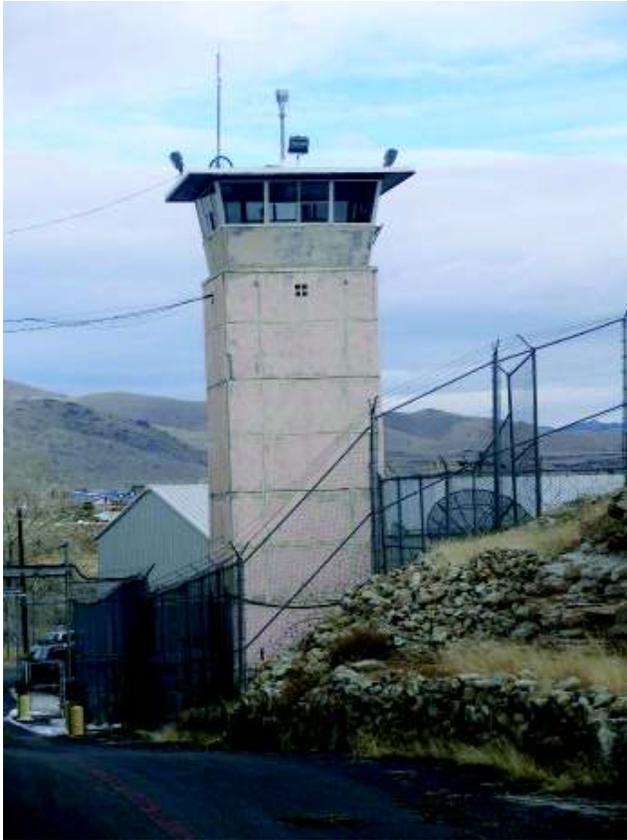
Guard Tower 2

- Guard Tower #2 is a painted precast concrete structure with a single-ply membrane roof.
- The tower is located inside of the secured area in the northeast corner of the site.
- It is three stories tall and has a 360 degree view of the prison grounds.
- It has 624 square feet of usable interior space which is accessed via a tall, winding, and intimidating staircase/ladder system.
- The tower is in fair condition.

- The roofing system was replaced in 2004.
- It would on require exterior maintenance for the representation of a prison security post.

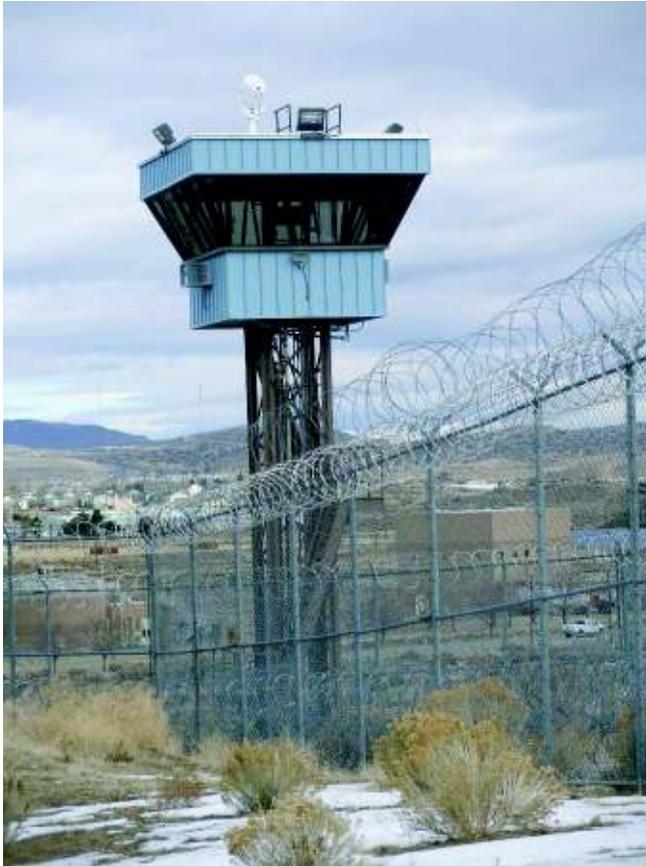
Guard Towers 3 & 4

- Guard Towers 3 and 4 are painted structural steel buildings with metal siding and roofs.
- They are located outside of the secured area in the northeast and southeast corners of the site.
- They were constructed in 1981, to serve as perimeter security for the “hill units”.
- The interiors allow for a 360 degree view of the prison grounds.
- The buildings are in fair shape though there are concerns regarding their structures.

- There is no projected use presented for these structures.
- Recommend be maintained in arrested decay.

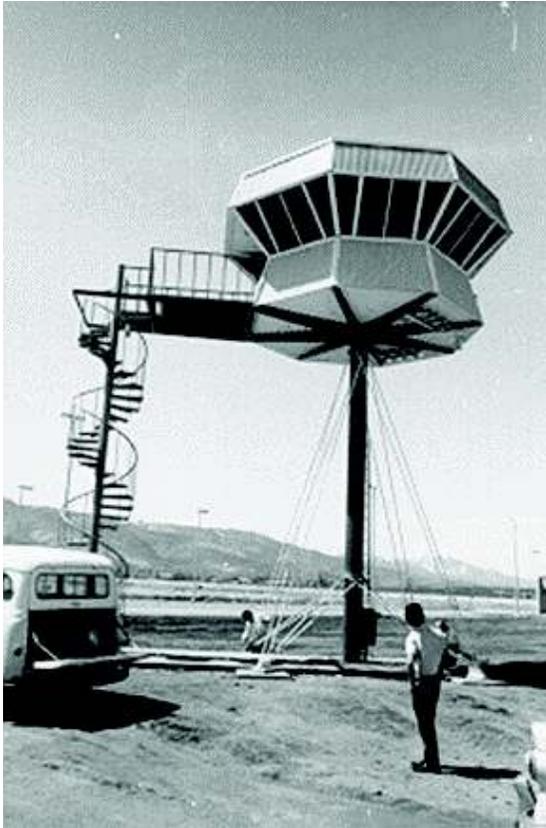
Tower 5

- Guard Tower #5 is a painted structural steel building (Space Needle) with metal siding and roof accessed by a steel spiral stairway.
- The tower is located outside of the secured area in the southwest corner of the site.
- The structure was constructed in 1966.
- There are windows that allow for a 360 degree view of the prison grounds.
- The building is in fair shape.

- There is no projected use presented for this structure.
- Recommend be maintained in arrested decay.

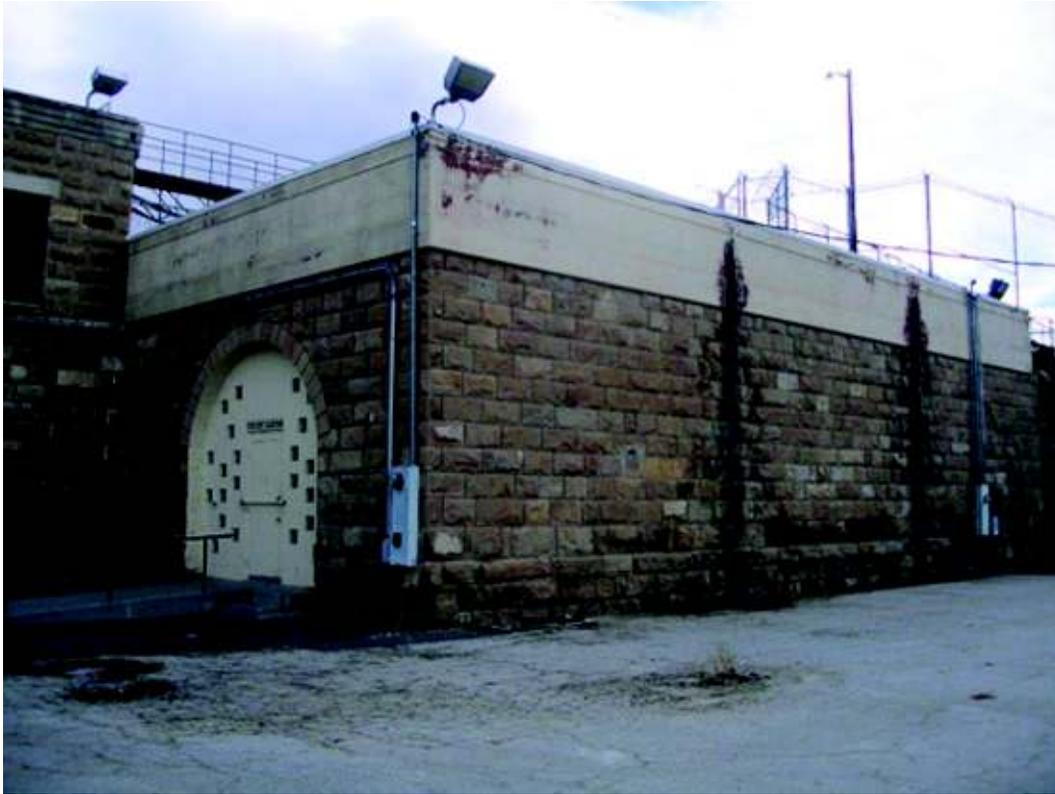
- The Courthouse is a stone masonry structure with a single-ply roof membrane.
- This building is attached to the Administration / Cell Block building and is one of the oldest structures on site.
- It was originally constructed in the 1927-28, as a sally port for major vehicle access to the old prison yard.
- It was covered with a roof in the 1960's as a construction project by the Synanon Foundation to provide 1,475 square feet of interior space.
- It then served as a chapel and offices for caseworkers.
- The facility was remodeled for court proceedings.
- The building is in fair shape

- The Courthouse is constructed of sandstone masonry walls on the exterior and wood framed interior walls and roof.
- The structure requires seismic strengthening to meet current life safety codes.
- This 1927-28 portion of the structure should be retrofitted to meet today's seismic standards.
- This project would cost approximately \$75,000.
- It is recommended that the building be painted in the next 3-5 years.

- The interior finishes are in fair condition.

- It is recommended that the interior walls be painted at least once in the next two to three years.
- The interior floor covering is mostly carpet and is showing signs of extreme wear.

- This replacement would cost approximately \$15,000.
- The building has a suspended acoustical tile ceiling system.
- The T-bar framing is bent and rusted in many areas and a number of the ceiling tiles are damaged and stained.

- Several areas are worn out and tears are evident throughout the carpeted areas causing a tripping hazard.
- This flooring should be replaced with carpet tile to allow for future replacement of only those sections of carpet that are worn or damaged without the need to remove the entire carpeted area.

- The replacement of this ceiling system would be nice but not immediately necessary at this time, regardless of its use.
- The estimate for this ceiling replacement is \$15,000.

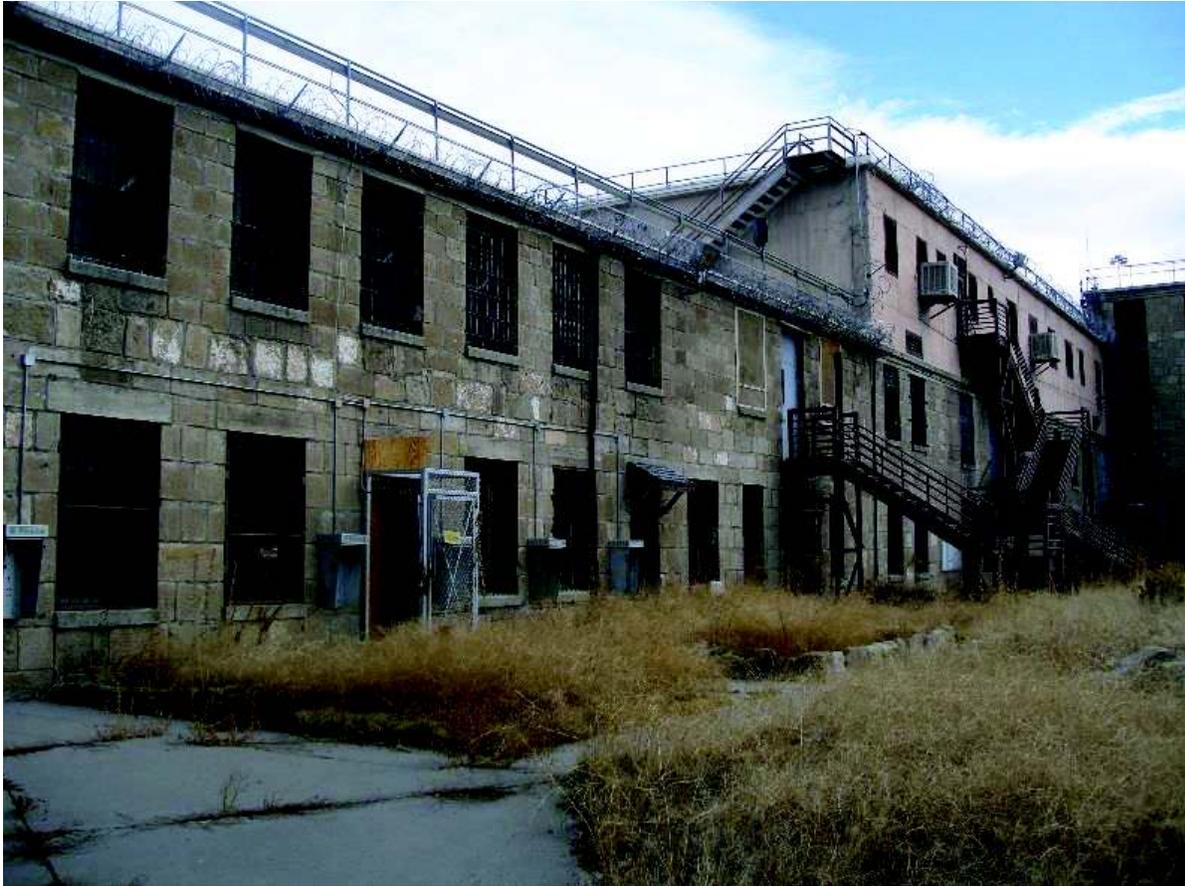
North Wing (Hospital Wing)

- The northern wing of the structure housed a complex assortment of functions.
- There is an access to a cellar area, called "Sagebrush", after the inmate newspaper that was once published by them.
- Today it simply provides access to some utilities.
- The first floor of the wing contained large, open, shop areas.
- These spaces are dim and worn, but could be remodeled for office or file space on an easily accessible ground level through doors that are outside the secure area of the structure.

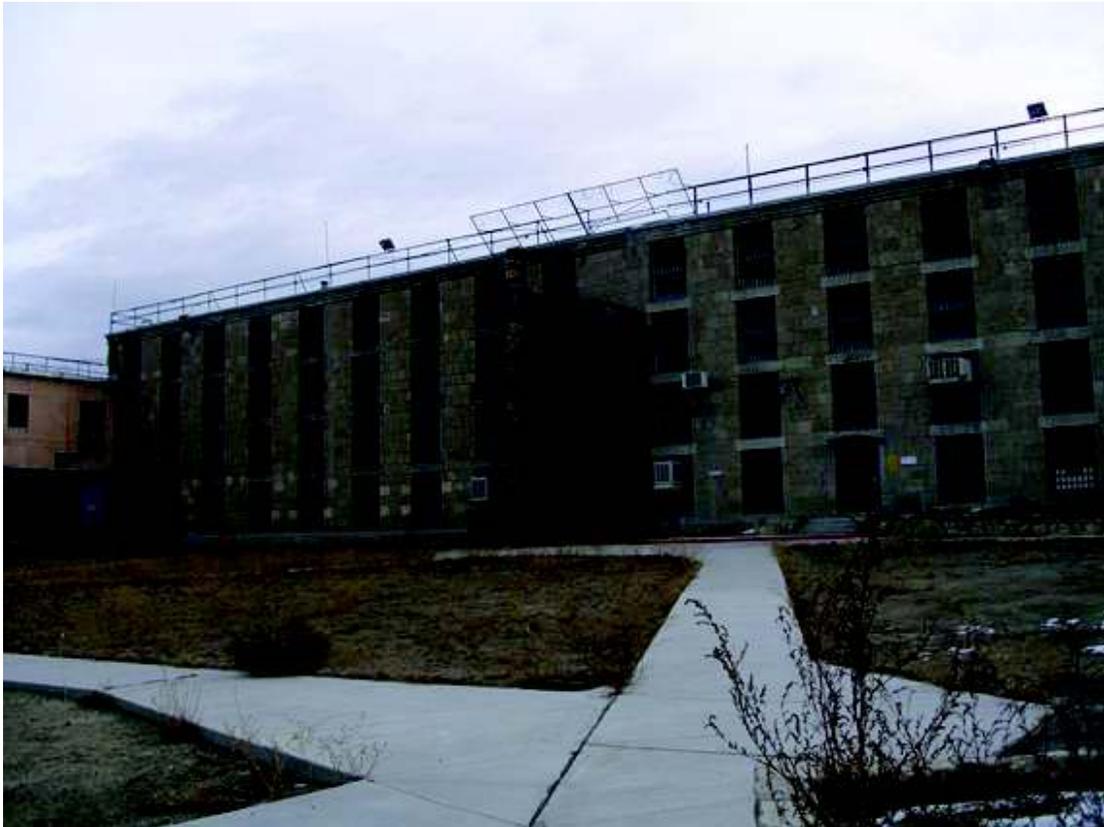
East Wing (Cell Blocks A & B)

- Easily hold 300 inmates
- A & B 4 stories
- A constructed in 1920-25
- B constructed in 1947-50
- Retrofit of bar – gates – hardware with construction of B block
- Interior cell configuration
- Cells inside
- Staff corridors outside next to windows
- Accessed by stairs only on north end of wing

- The existing building exterior is natural sandstone that was quarried directly from the correctional facility site.
- There are numerous areas where the mortar is failing, missing and not sealed properly due the age and exposure to the weather.

- Some of the window units are cracked or damaged, seals are broken, are difficult to operate and they have reached the end of their useful life.
- Prior to painting, all surfaces should be repaired to address the extensive wall issues.

- The existing concrete stairs are showing signs of wear and deterioration.
- Floors in this building are concrete and require no work for any proposed use.

- Electrical and plumbing access is through a "pipe chase" that runs through the center of the building.
- These utilities are worn and inadequate for use as an institution.
- The utilities are not a significant issue for the proposed uses of the structure.
- Some of the domestic water and waste lines have been damaged or shut down, mainly water in Unit 2 and 5 and waste lines in Unit 2.
- An inspection was performed on this building in 1989, for asbestos containing materials (ACM).
- The majority of the building is heated by steam provided from the Boiler Room structure.
- There is no cooling except for numerous evaporative coolers mounted on the roof of Unit 3 which are not ducted to all levels of the structure

- The majority of the utilities in the Cell house are located in the "pipe chase" and are original, with a few areas repaired or replaced.
- At the time of the 2009 survey, all of unit 5 and some of unit 3 were having problems and the system was not 100 percent operational. Some of the pipe, hangers, connectors and couplers are deteriorating and water leaks are developing.

- Dielectric corrosion is occurring between different types of pipe metals, internal corrosion is occurring on the 4" pipe and compression clamps are located in areas where leaks have occurred.

- Other small repairs have been done over time as needed to keep system operational.
- A break in the pipe has the potential to short out the power supply, alarm system, flood the lowest levels of the building and presents a safety hazard.

- A project for replacing the utilities in the "Sagebrush" basement area was completed in 2001.
- This building is equipped with an automatic fire detection and alarm system, but the system is old, does not meet current code requirements and is missing in some locations.

- Cleaning, repair and re-pointing of the exterior stone work is necessary.
- Due to the vertical nature of the building, scaffolding will be required to accomplish this project.

- Not included in the previous testing was lead paint encapsulation and other possible environmental hazards.
- The cost of this inspection would depend on the intended use of the various portions of the structure.

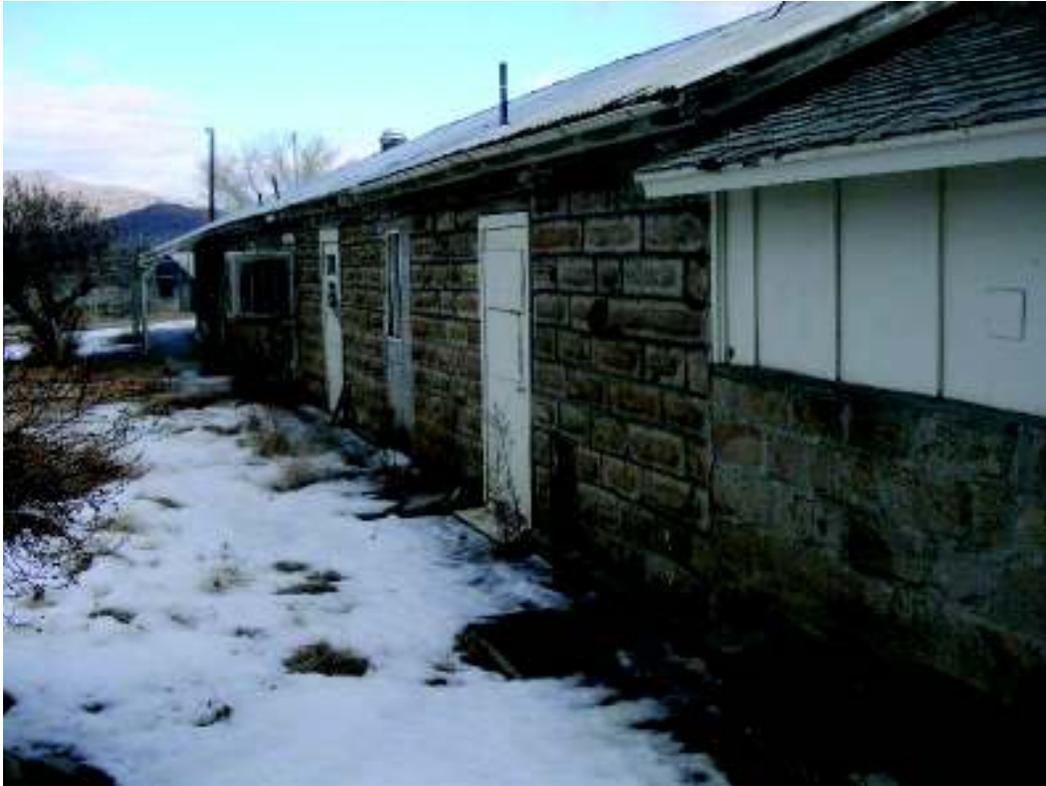
- The Storage and Maintenance Office is a stone masonry and wood framed structure on a concrete slab-on-grade.
- The building has low hazard storage adjacent to the welding shop.
- The roofing is corrugated metal.
- The building contains small office areas, storage areas, a welding area and restrooms in roughly 3 separate spaces and three different occupancies.
- Some portions of this structure are over 50 years old.
- 2,190 sf.
- Constructed in 1952
- The structure is in fair shape.

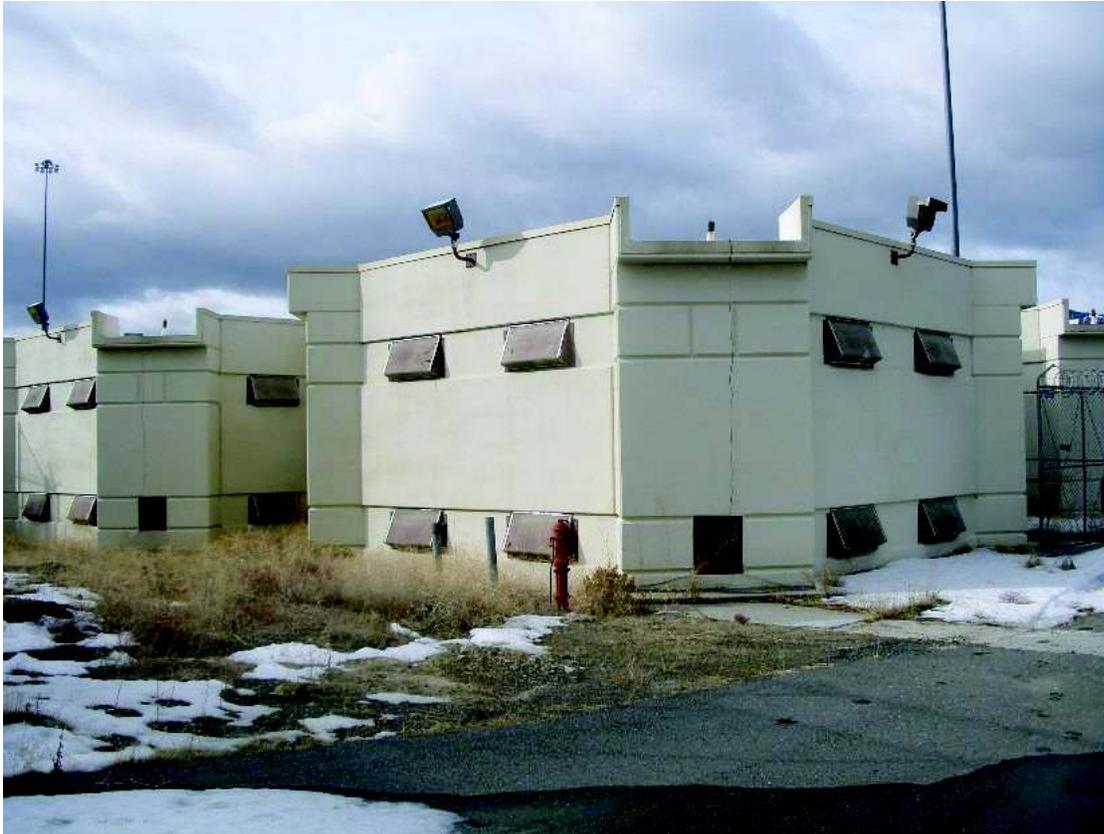
Units 6-7-8-9-10-11

- These housing units are known as the "Hill Units" and are painted precast concrete structures with single-ply membrane roofs
- Each contain 48 cells for 98 inmates, showers and a central control room all on two levels.
- The units are in fair shape.
- Each unit has 7,801 sf of space and were constructed in 1981.
