Re: Docket No. 12-07021; Filing of Environmental Statement

ENVIRONMENTAL STATEMENT

Townsite Solar Project

September 4, 2019

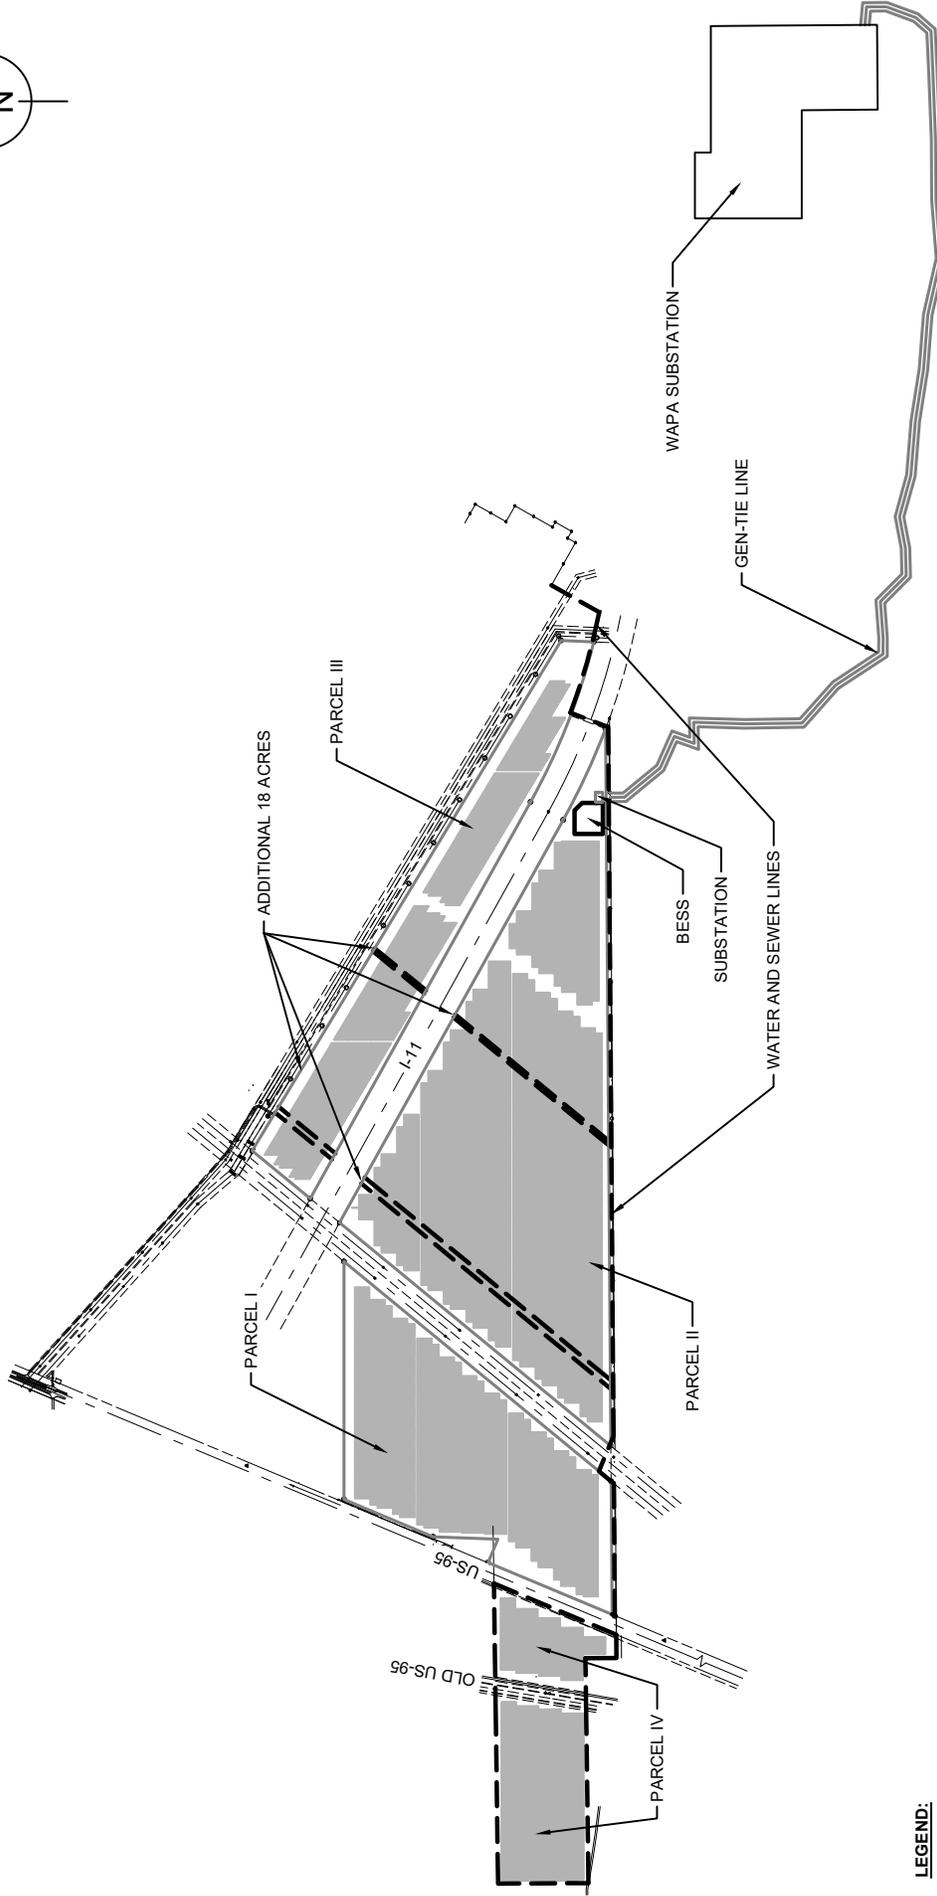
ENVIRONMENTAL
STATEMENT PROJECT
DESCRIPTION FIGURE 1

The complete Townsite Solar Project encompasses a total of 1083 acres including 1,033 acres of municipally-owned land for solar panels and ancillary equipment plus approximately 50 acres of land managed by the Western Area Power Administration for the right of way required for the 230-kV GenTie (Figure 1).

The additional solar facilities, BESS systems, and waterlines are primarily located on the 3 large tracks of land owned and leased by the City of Boulder City, the eastern edge of which is approximately 500 feet west of the Boulder City Wastewater Treatment Plant. The study area for the 2013 EA included approximately 902 acres within parcels I, II, III, and approximately 50 acres for the GenTie, these areas are outlined in solid gray on Figure 1.

The additional 131-acre expansion area is located on the west side of U.S. Highway 95 immediately to the west of the original project site. This area was not included in the June 2013 EA; therefore, it is addressed in this Environmental Statement.
